Report No.: HXO0026/2022

Notebook - Commercial Product Description:

Style/ Item No.: HP ProBook 440 14 inch G10 Notebook PC/ A5CD24161X1

We have tested the submitted sample(s) as requested and the following results were obtained: Test Required:

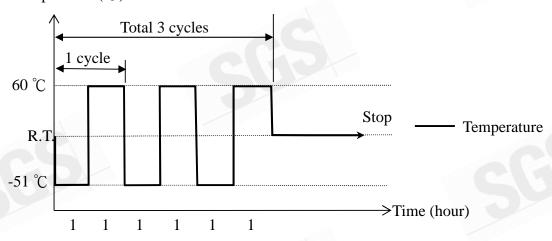
MIL-STD-810H:2019, Method 503.7, Procedure I-C and client's request

Temperature (°C)

- The temperature transition time shall be within 1 minute.
- Sample condition: Non-Operating
- Examine the appearance of specimen(s) by visual check and perform functional after this test.
- Functional Check: Turn on the power of specimen(s) then examine whether the booting function of specimen(s) could be work normally or not.
